International Journal of Scientific Research and Reviews

Conservation and Restoration of the Major Water Supply Source of Jaipur City: Ramgarh Dam

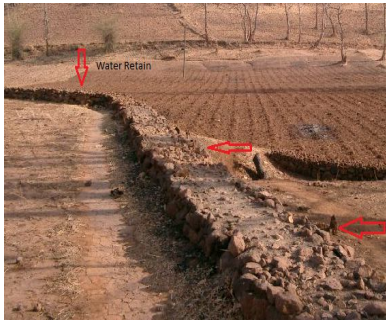
Fig 1 (a) Watershed Activity

height of contour bunding can be observed from 2.0 to 5.0 m and they covers almost entire hills in the forest area. Due to unplanned construction of these bundings, water is entrapped before coming to drain. Fig 1(a) shows obstruction in water flow by constructing bund by forest department.

1. All activities in the catchment area by different departments which are contributing in deterioration of the catchment may be stopped immediately.
2. Water bodies having high structures can be gated and water bodies of low height can be modified by constructing spillway/overflow structures in such a way that the water column retained in any water body may be restricted to 0.75 m only which will serve the purpose of local needs and surplus water will be allowed into main reservoir.

3. The respective department may be asked to modify their structures and to remove obstructions from local nallah, drain etc. which otherwise are responsible for impending flow into main river course.

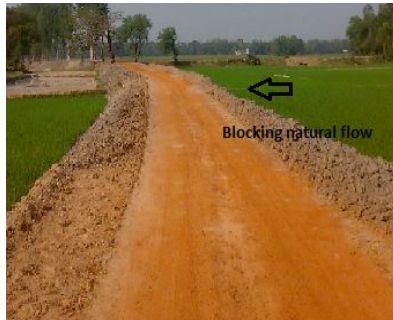
(b) Rural Road

- It is also observed that several roads have been constructed by various agencies raised to 1-3 m high embankments in the catchment area and at some places the roads are constructed across the main river obstructing a significant volume of water. No provision for cross drainage work has been made. Fig 1(b) shows example of gravel rural road constructed under Mahatama Gandhi National Employment Guarantee (MNERGA).

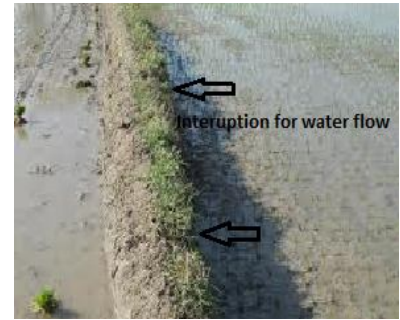
(c) Small Mud or Dols

- In most of the catchment areas, farmers have constructed water harvesting structures in the forms of Dols or Mud –bundi (low height earthen dams) in their farms, which harvest water for their local purpose. This practice retains significant water by obstructing the flow created in the stream, resulting in less runoff. Fig 1(c) shows small dols/mud- bundi which obstructs natural flow of water. As land holding decreases with increase in farmer's population, these dols are used to divide the land during partition.
